ENVIRONMENTAL ASSESSMENT (EA)  
FOR RUNWAY 10-28 TREE OBSTRUCTION REMOVAL  
GREATER ROCHESTER INTERNATIONAL AIRPORT (ROC)

FAA AIP NO. 3-36-0102-103-2019  
CA NO. 1736

January 2020

Prepared By:  
CHA Consulting, Inc.

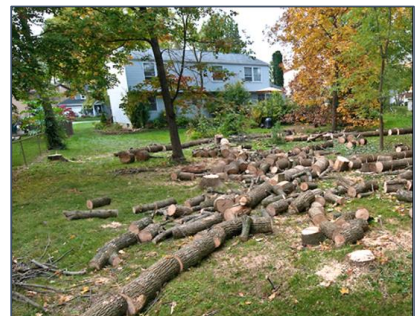
**Sample:** Selective tree removal underway in a residential area, with shorter trees left in place.

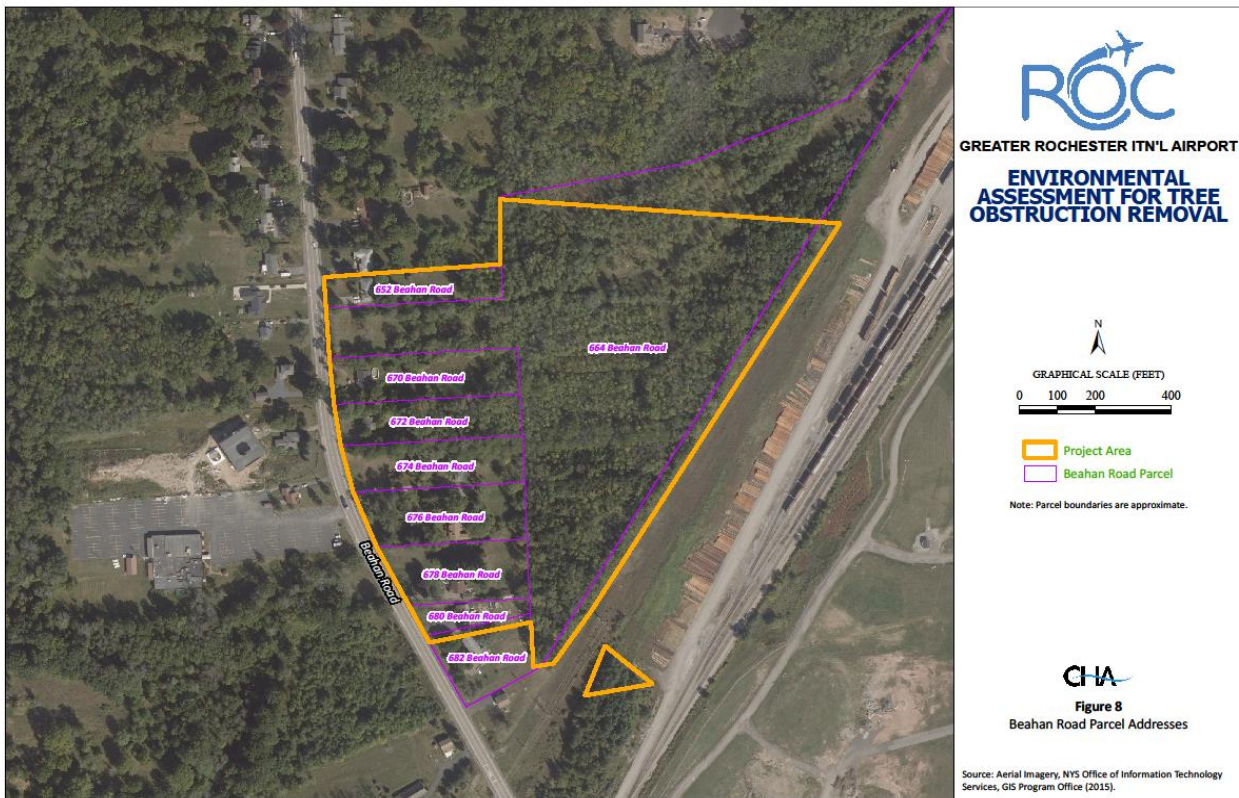
**Figure 9 – Beahan Road Parcel Addresses**

- Rear of 682 Beahan Road – debris, drums, scrap metal, old equipment along wood line.
- Rear of 680 Beahan Road – large pile of wood scrap, drums, plastic buckets, cans, cinder blocks.
- Airport property to rear of 676 Beahan Road – discarded materials consisting of propane tank, scrap metal, tile, concrete, glass trash, rusted paint cans, and a small engine with attached gas tank. In addition, a gasoline odor was noted in that general area during the site inspection.

For the residential properties identified below, no stump removal or grading will occur at these locations in order to avoid the potential to disturb potentially hazardous materials. If desired by property owners, tree stumps would be ground down to existing grade level and covered with top soil and seed. This method would prevent disturbance of any existing hazardous materials that may be present. This project will not include any hazardous material remediation.

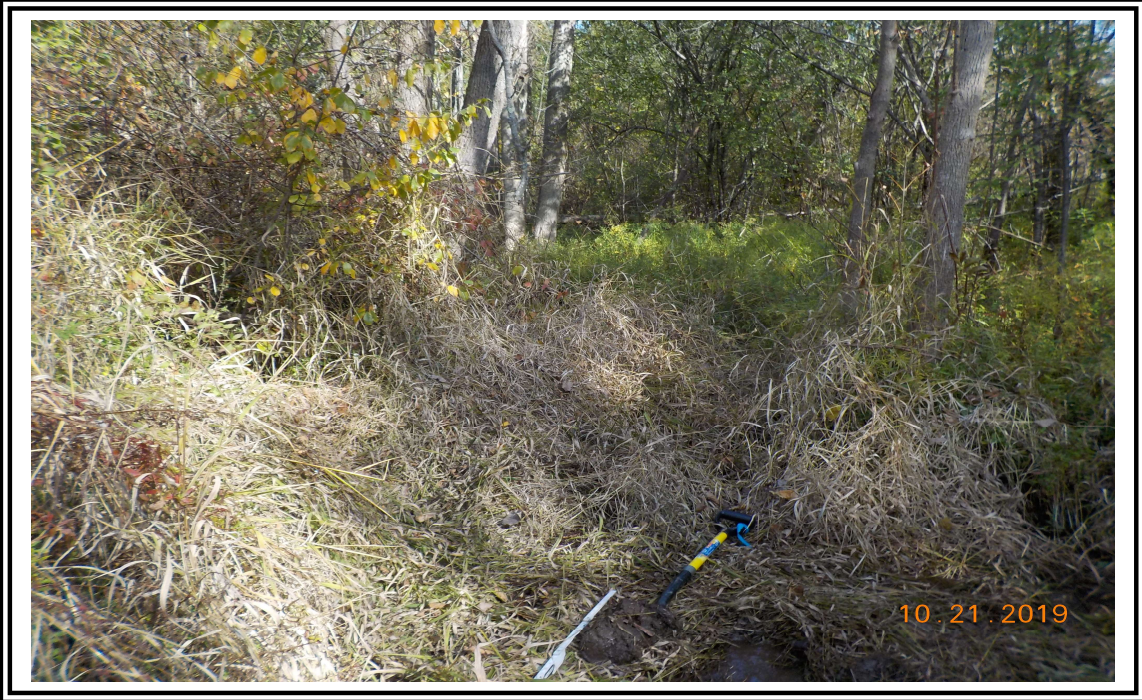
**Photo 1-Wetland at data point A-32.**

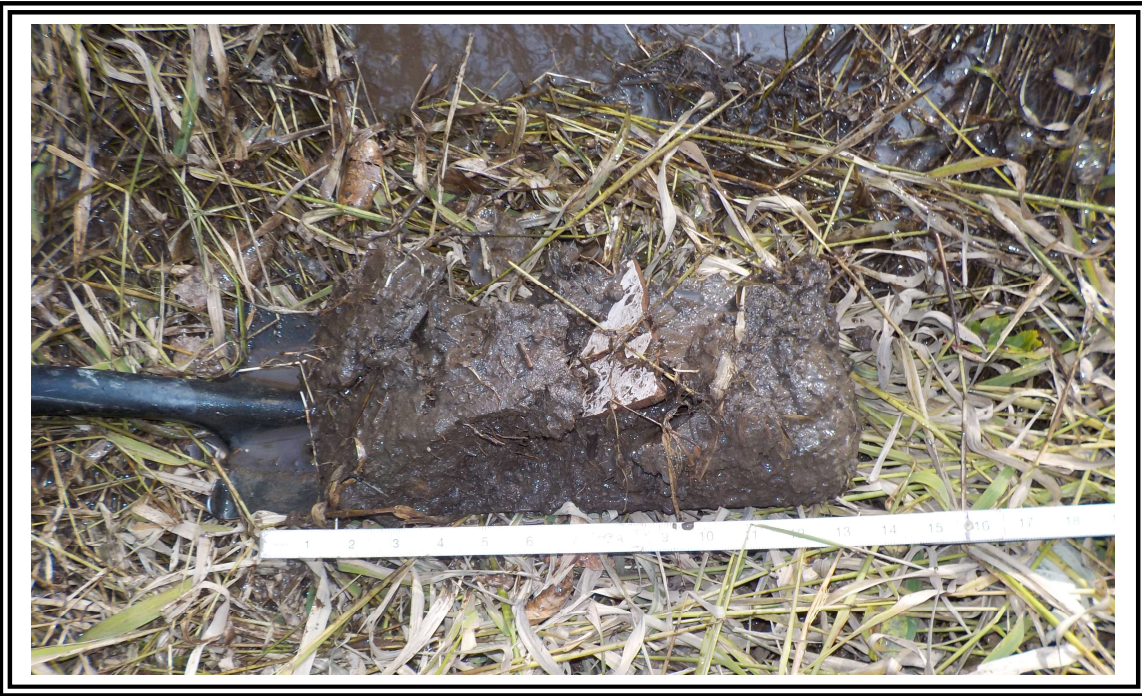
**Photo 2- Soil at wetland data point A-32.**

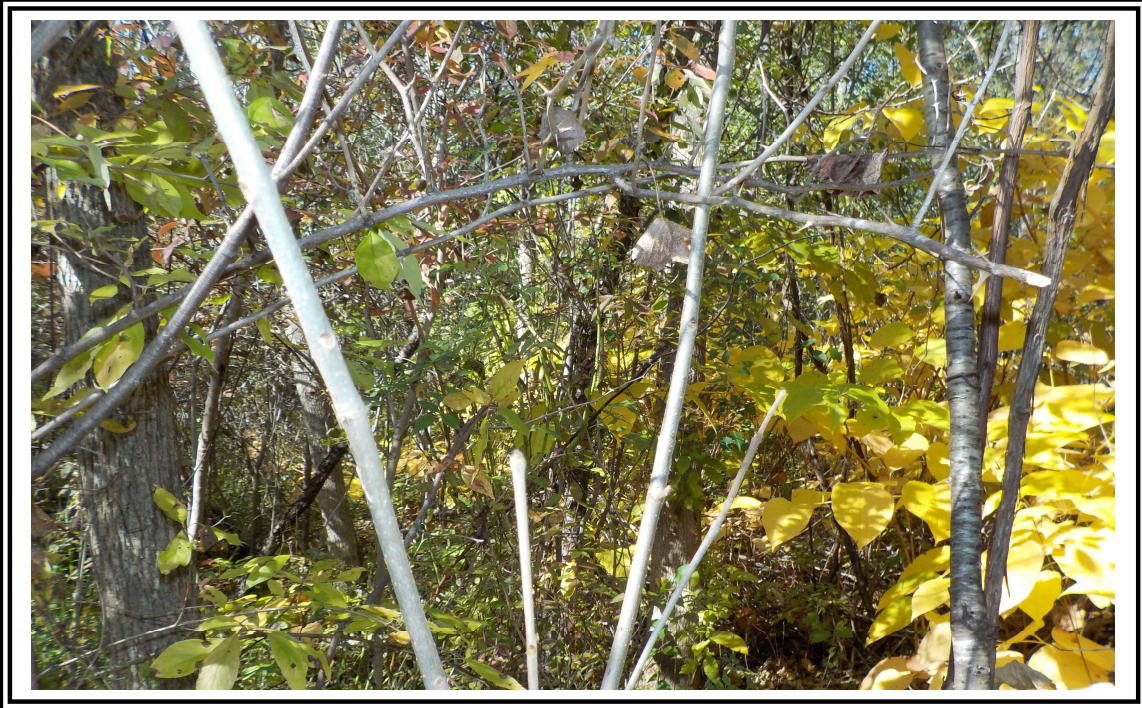
**Photo 3- Dry land at data point A-32.**

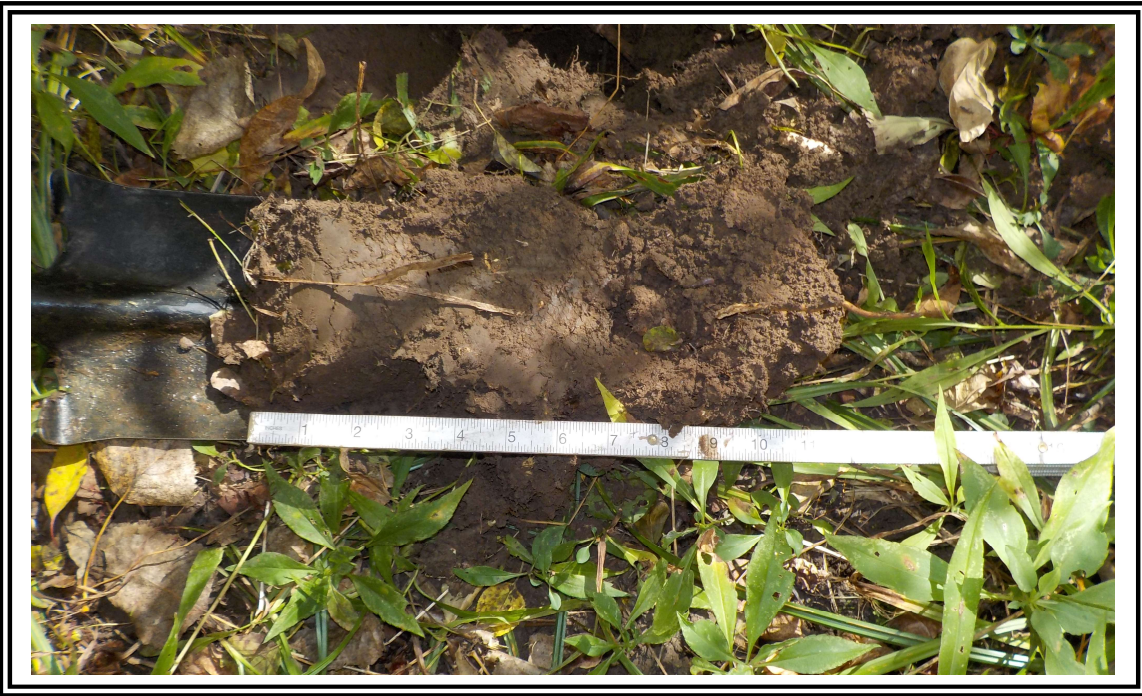
**Photo 4- Soil at dry land data point A-32.**

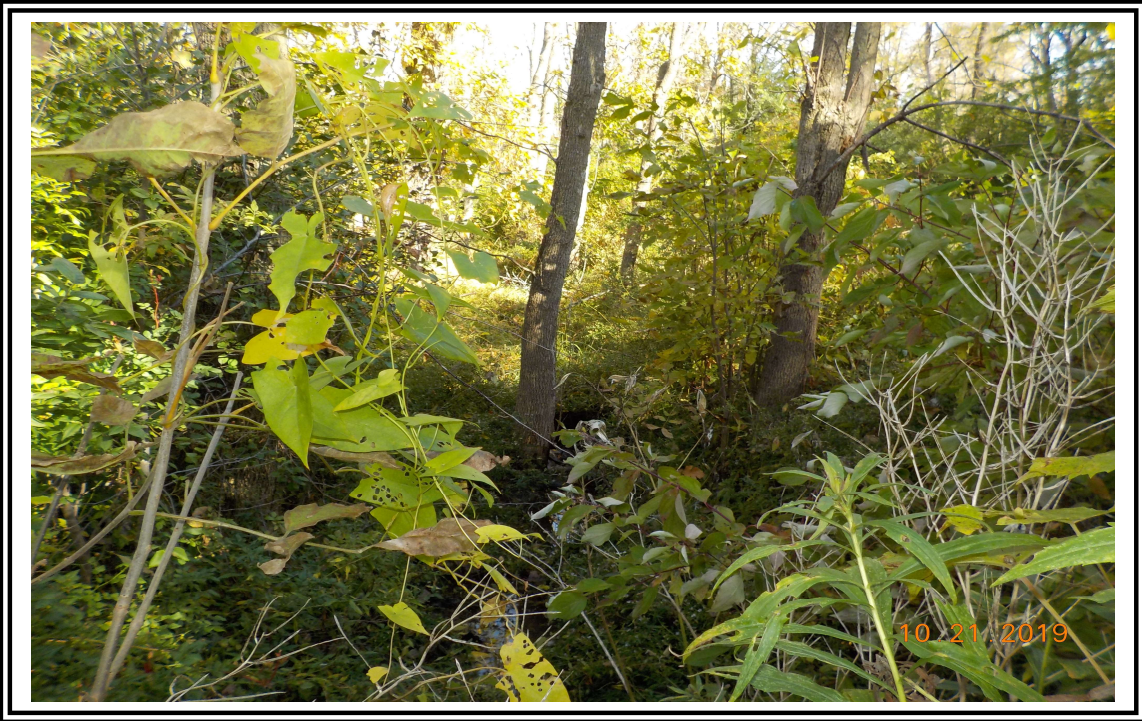
**Photo 5-View of the stream near flag A-49.**

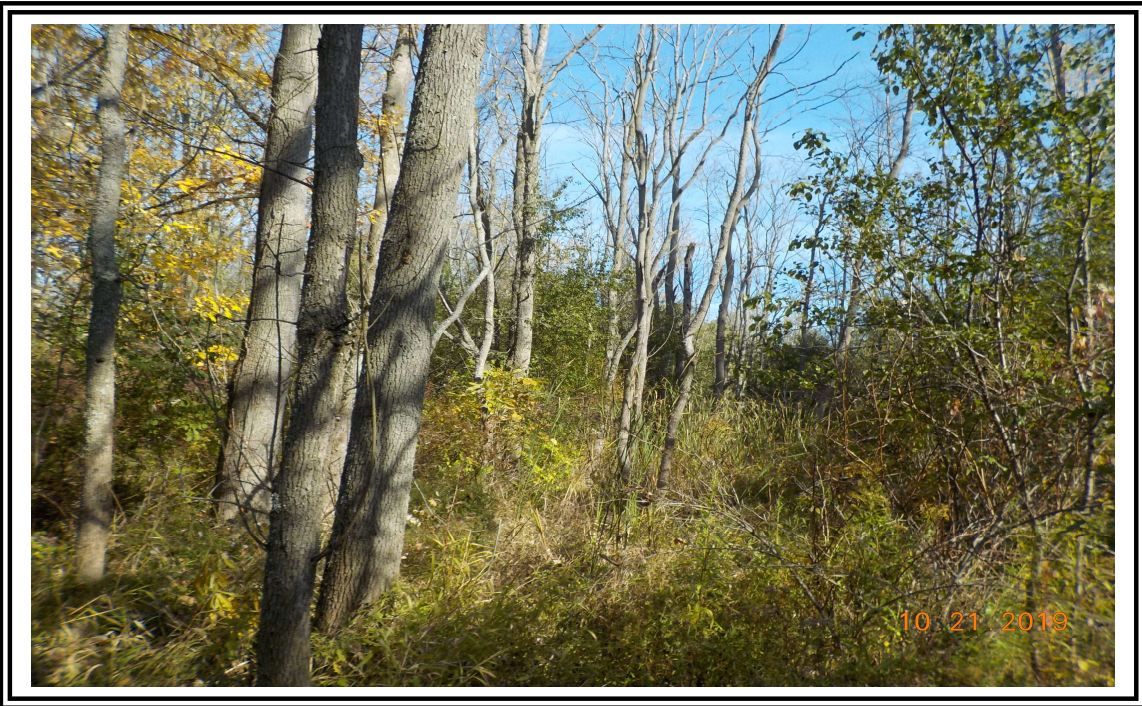
**Photo 6-View of wetland near flag A-6 facing east.**

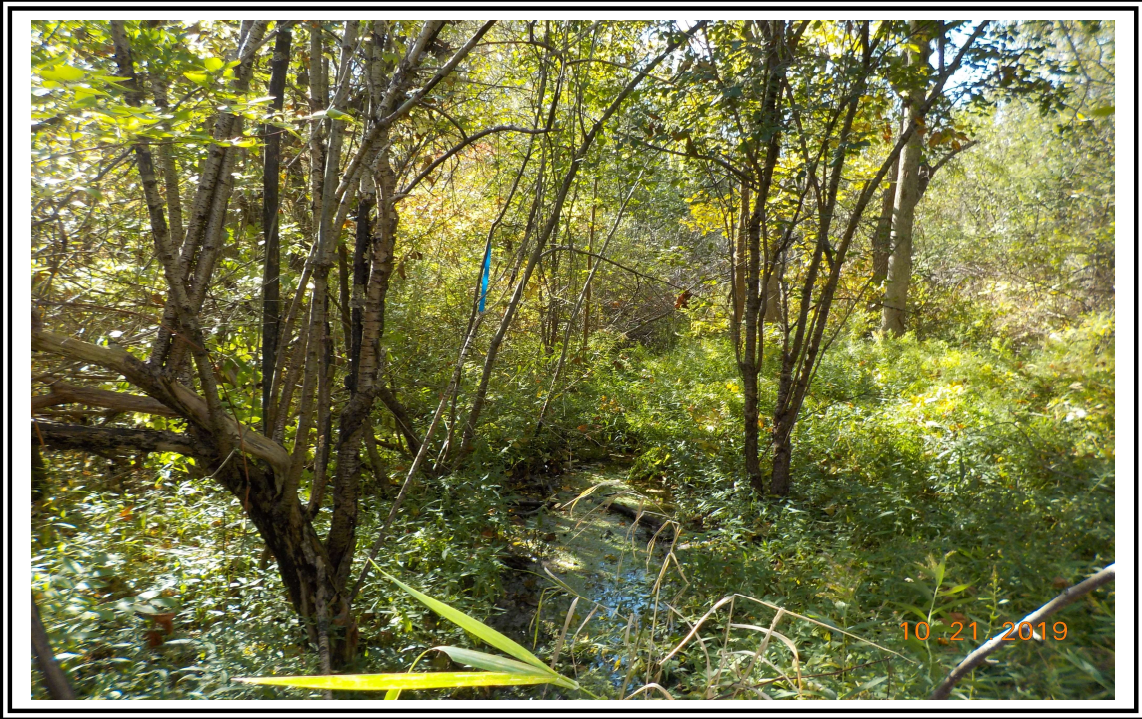
**Photo 7-View of stream and wetland near flag A-13.**

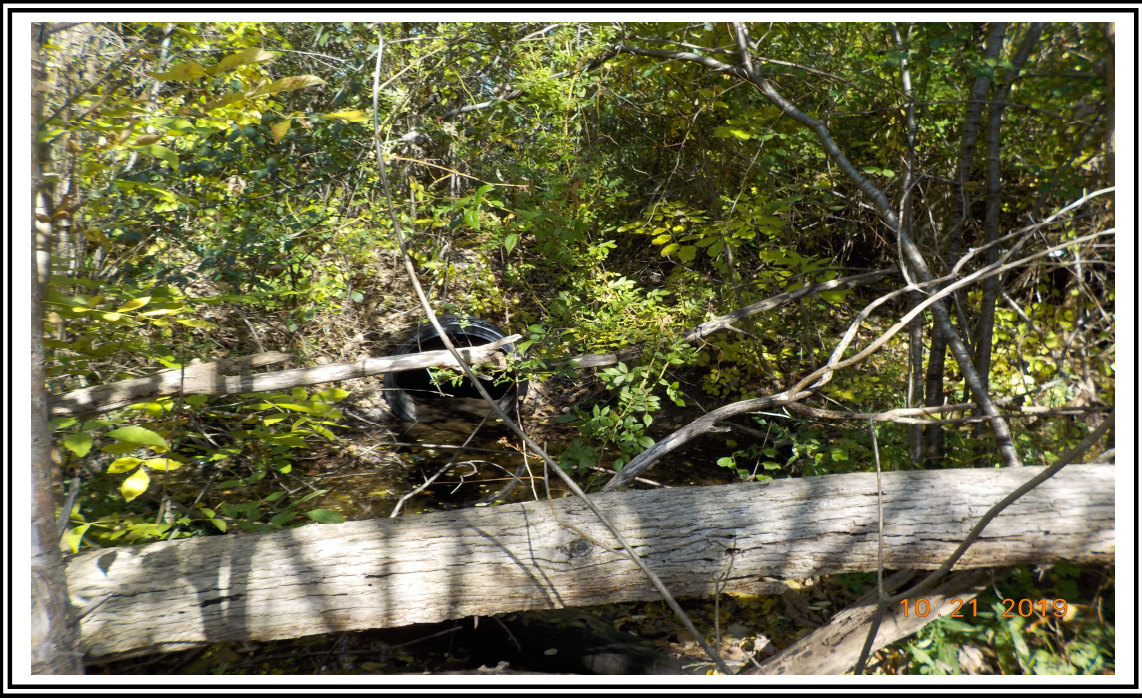
**Photo 8-View of culvert near flag A-14.**

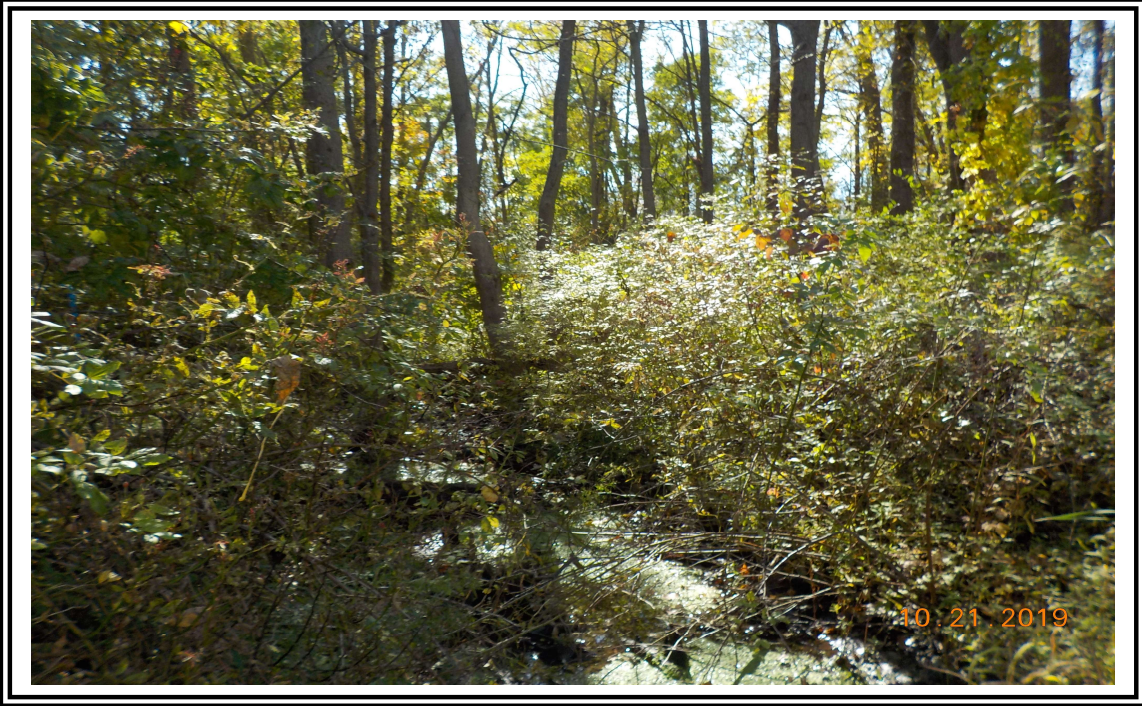
**Photo 9-View of the stream at flag A-22 facing south.**

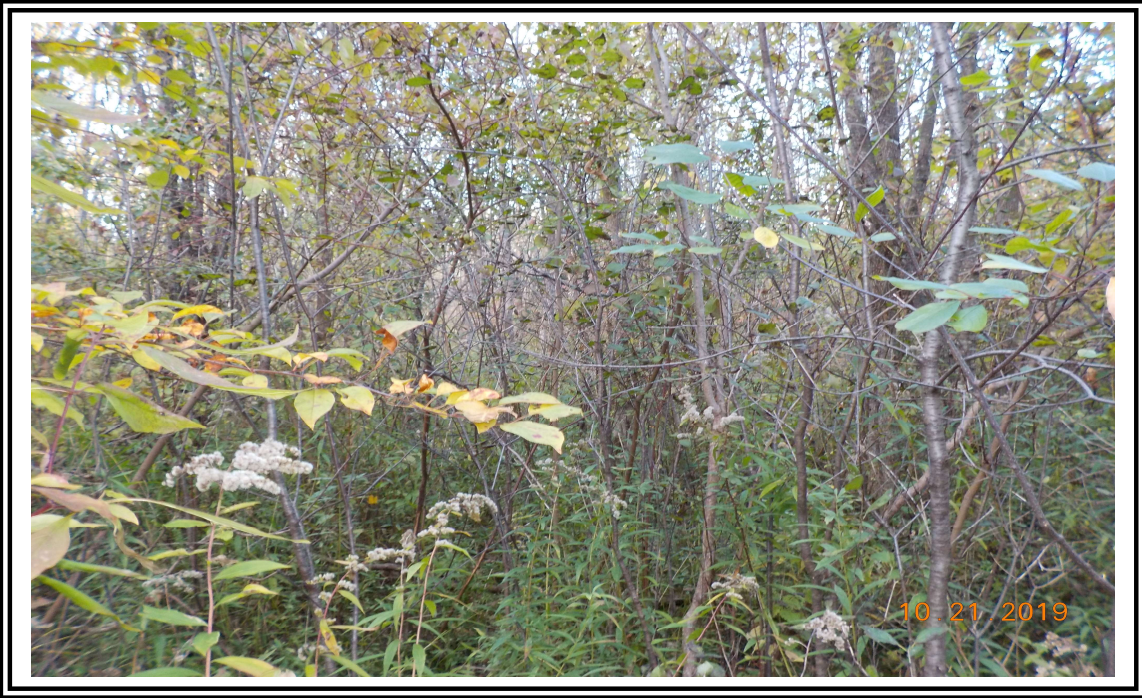
**Photo 10- Wetland at data point B-19.**

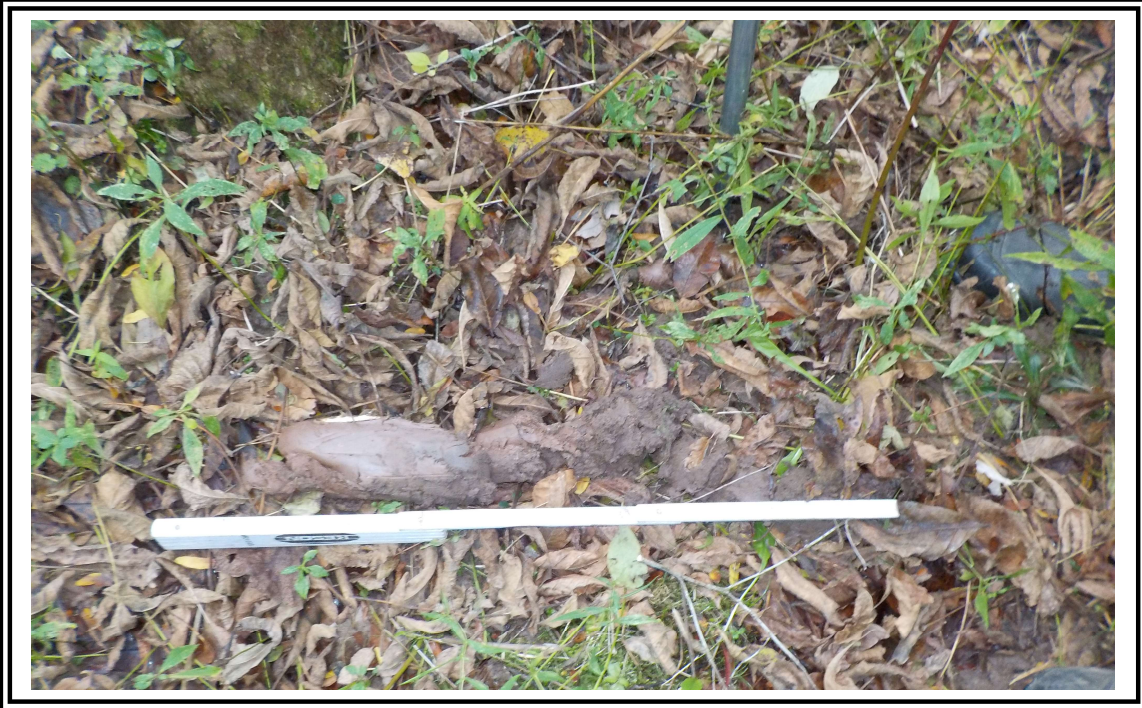
**Photo 11- Soil at wetland data point B-19.**

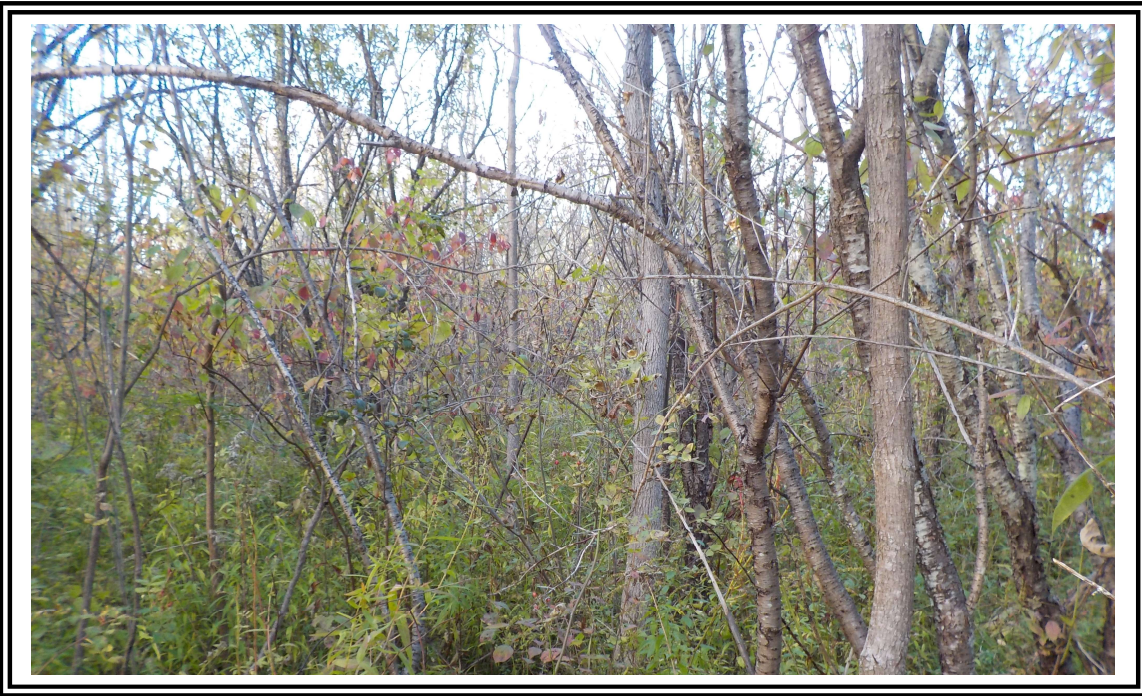
**Photo 12- Dry land at data point B-15.**

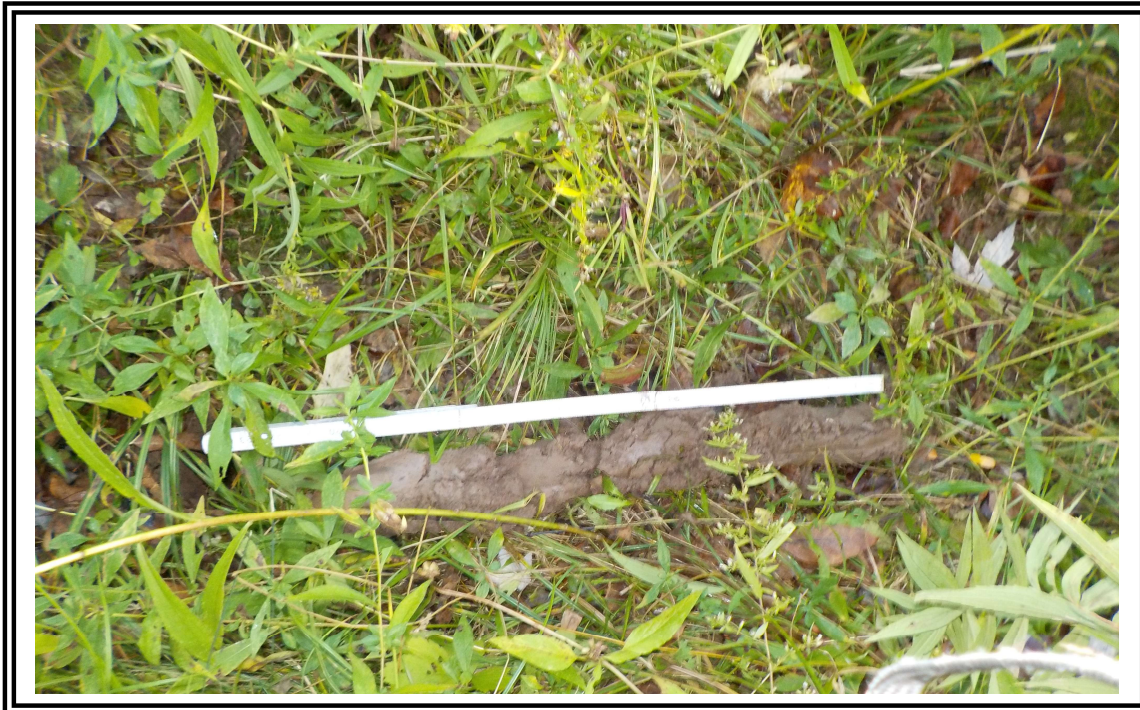
**Photo 13- Soil at dry land data point B-15.**

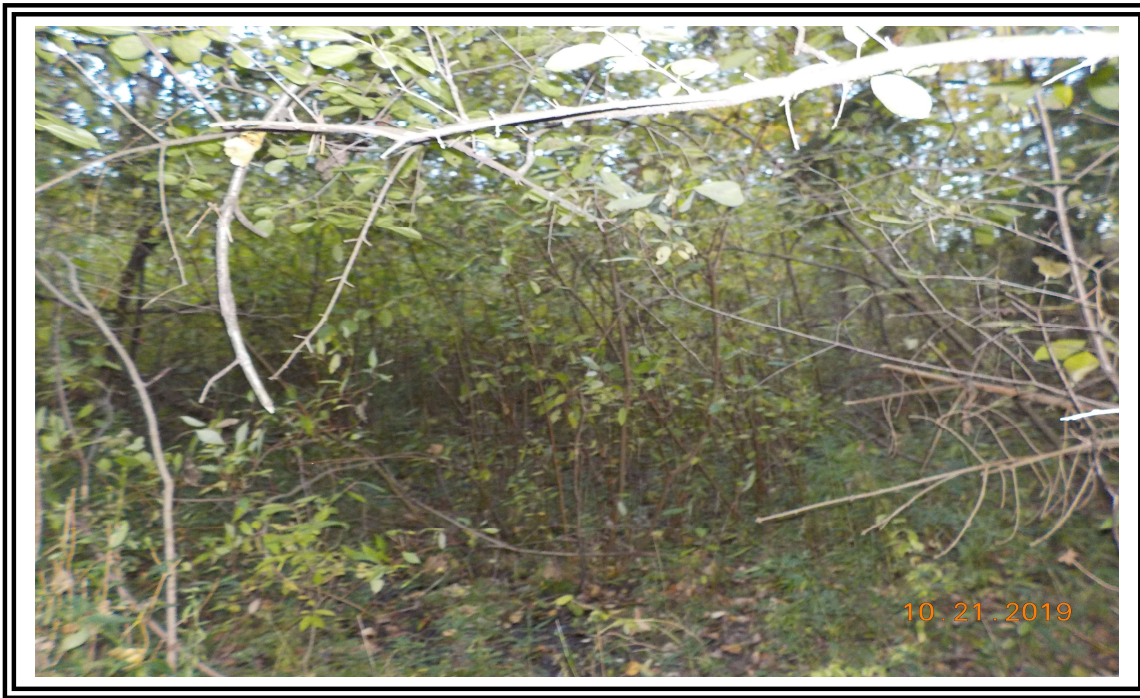
**Photo 14- Wetland at data point C-2.**

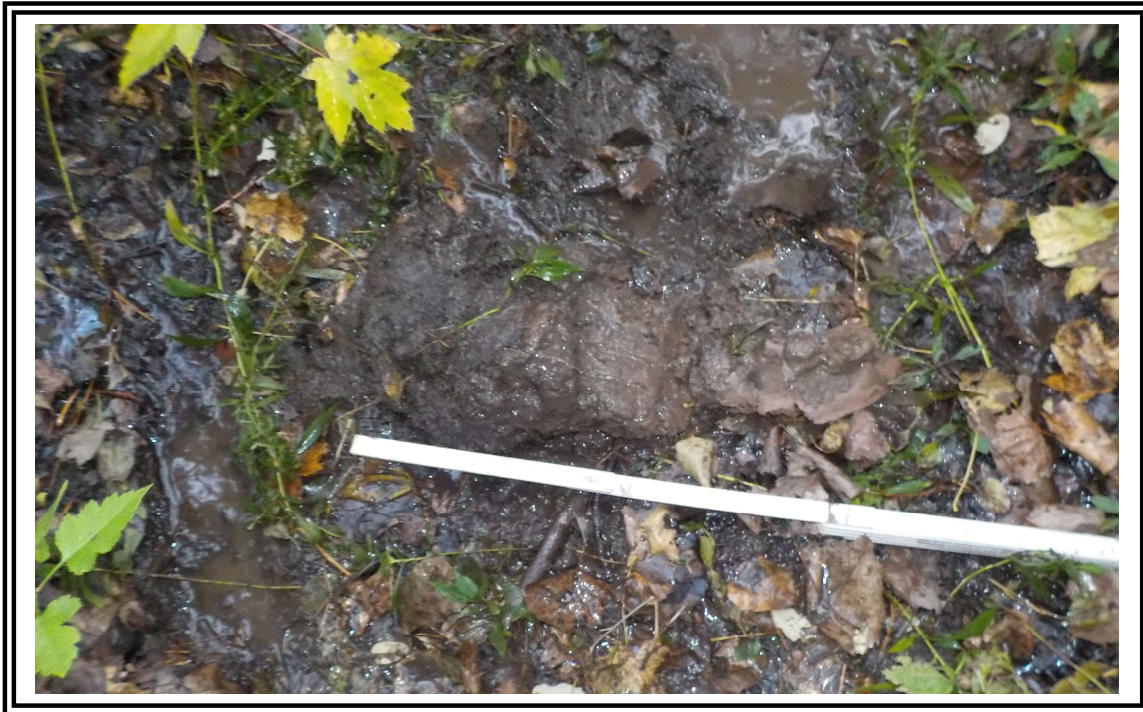
**Photo 15- Soil at wetland data point C-2.**

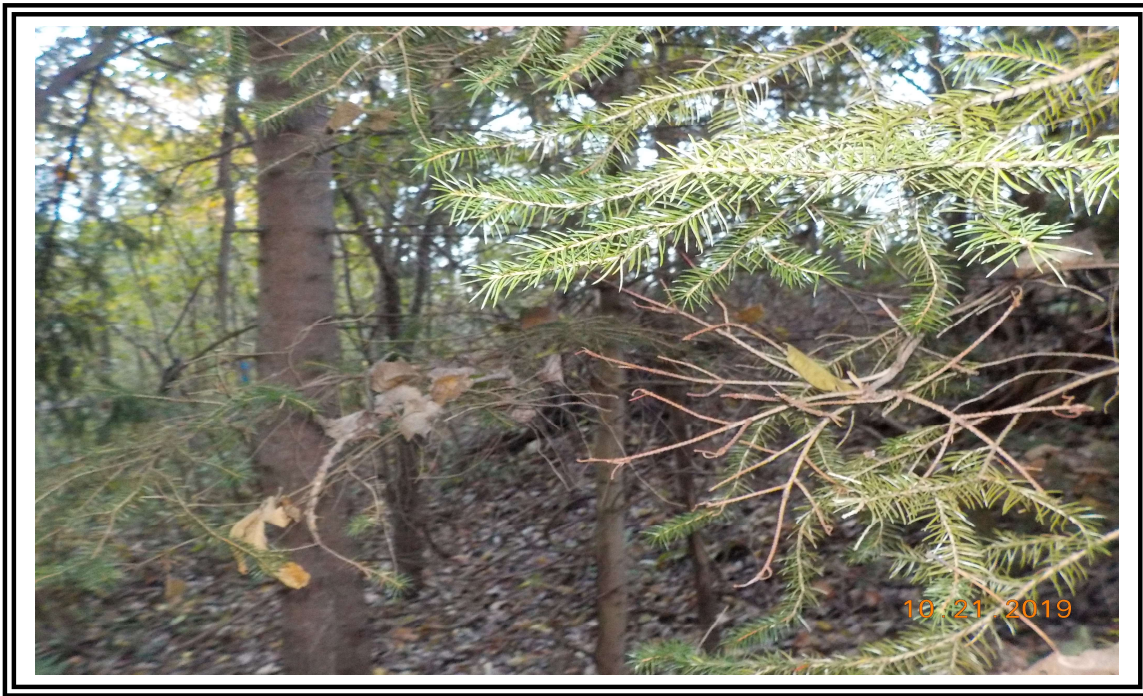
**Photo 16- Dry land at data point C-2.**

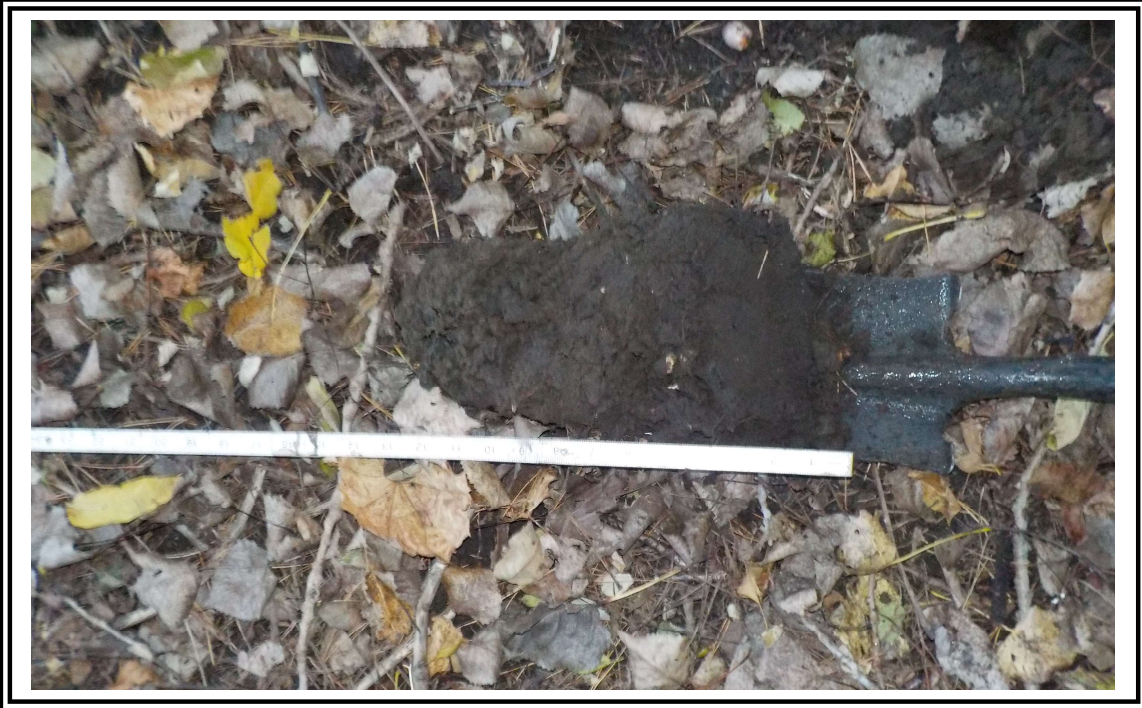
**Photo 17- Soil at dry land data point C-2.**

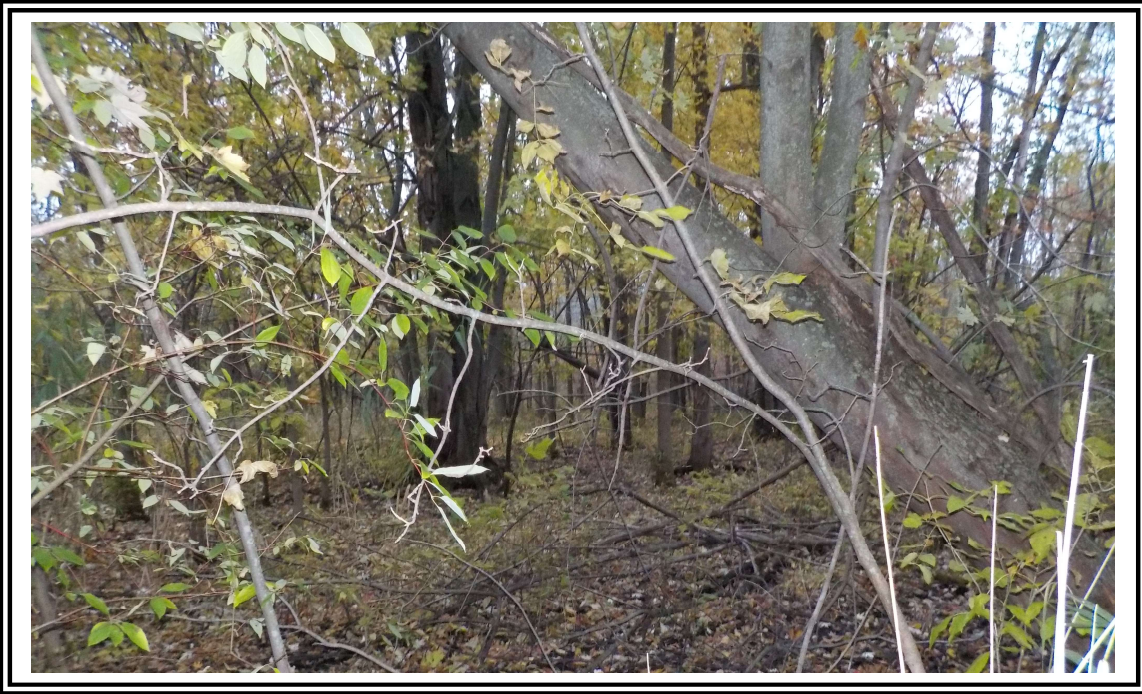
**Photo 18-View of wetland near flag C-24 facing south.**

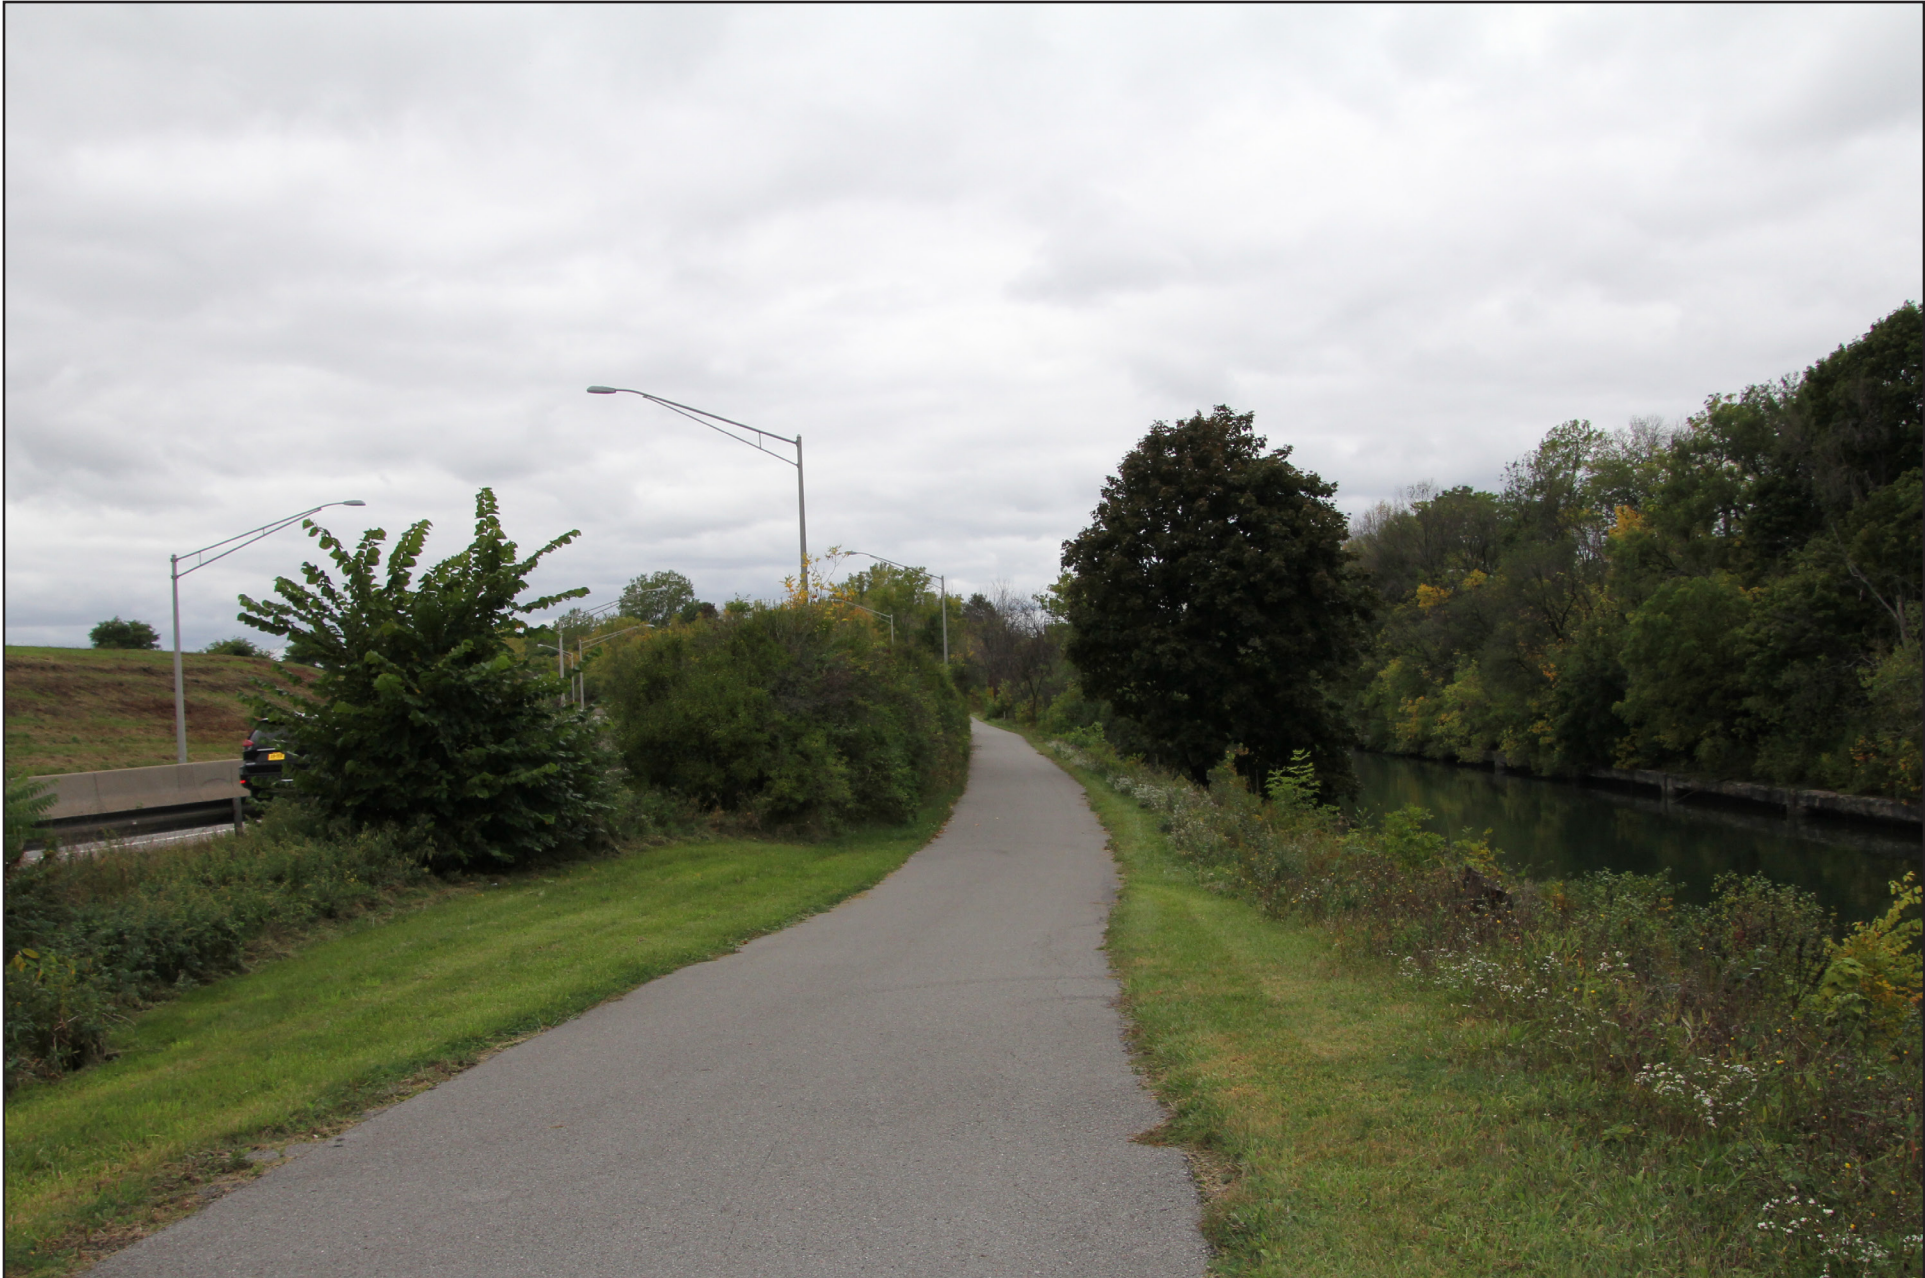
**Figure 2. Key View 1: Existing Conditions**  
Greater Rochester International Airport  
Off Airport Tree Obstruction Removal  
Town of Chili & City of Rochester, Monroe County, NY

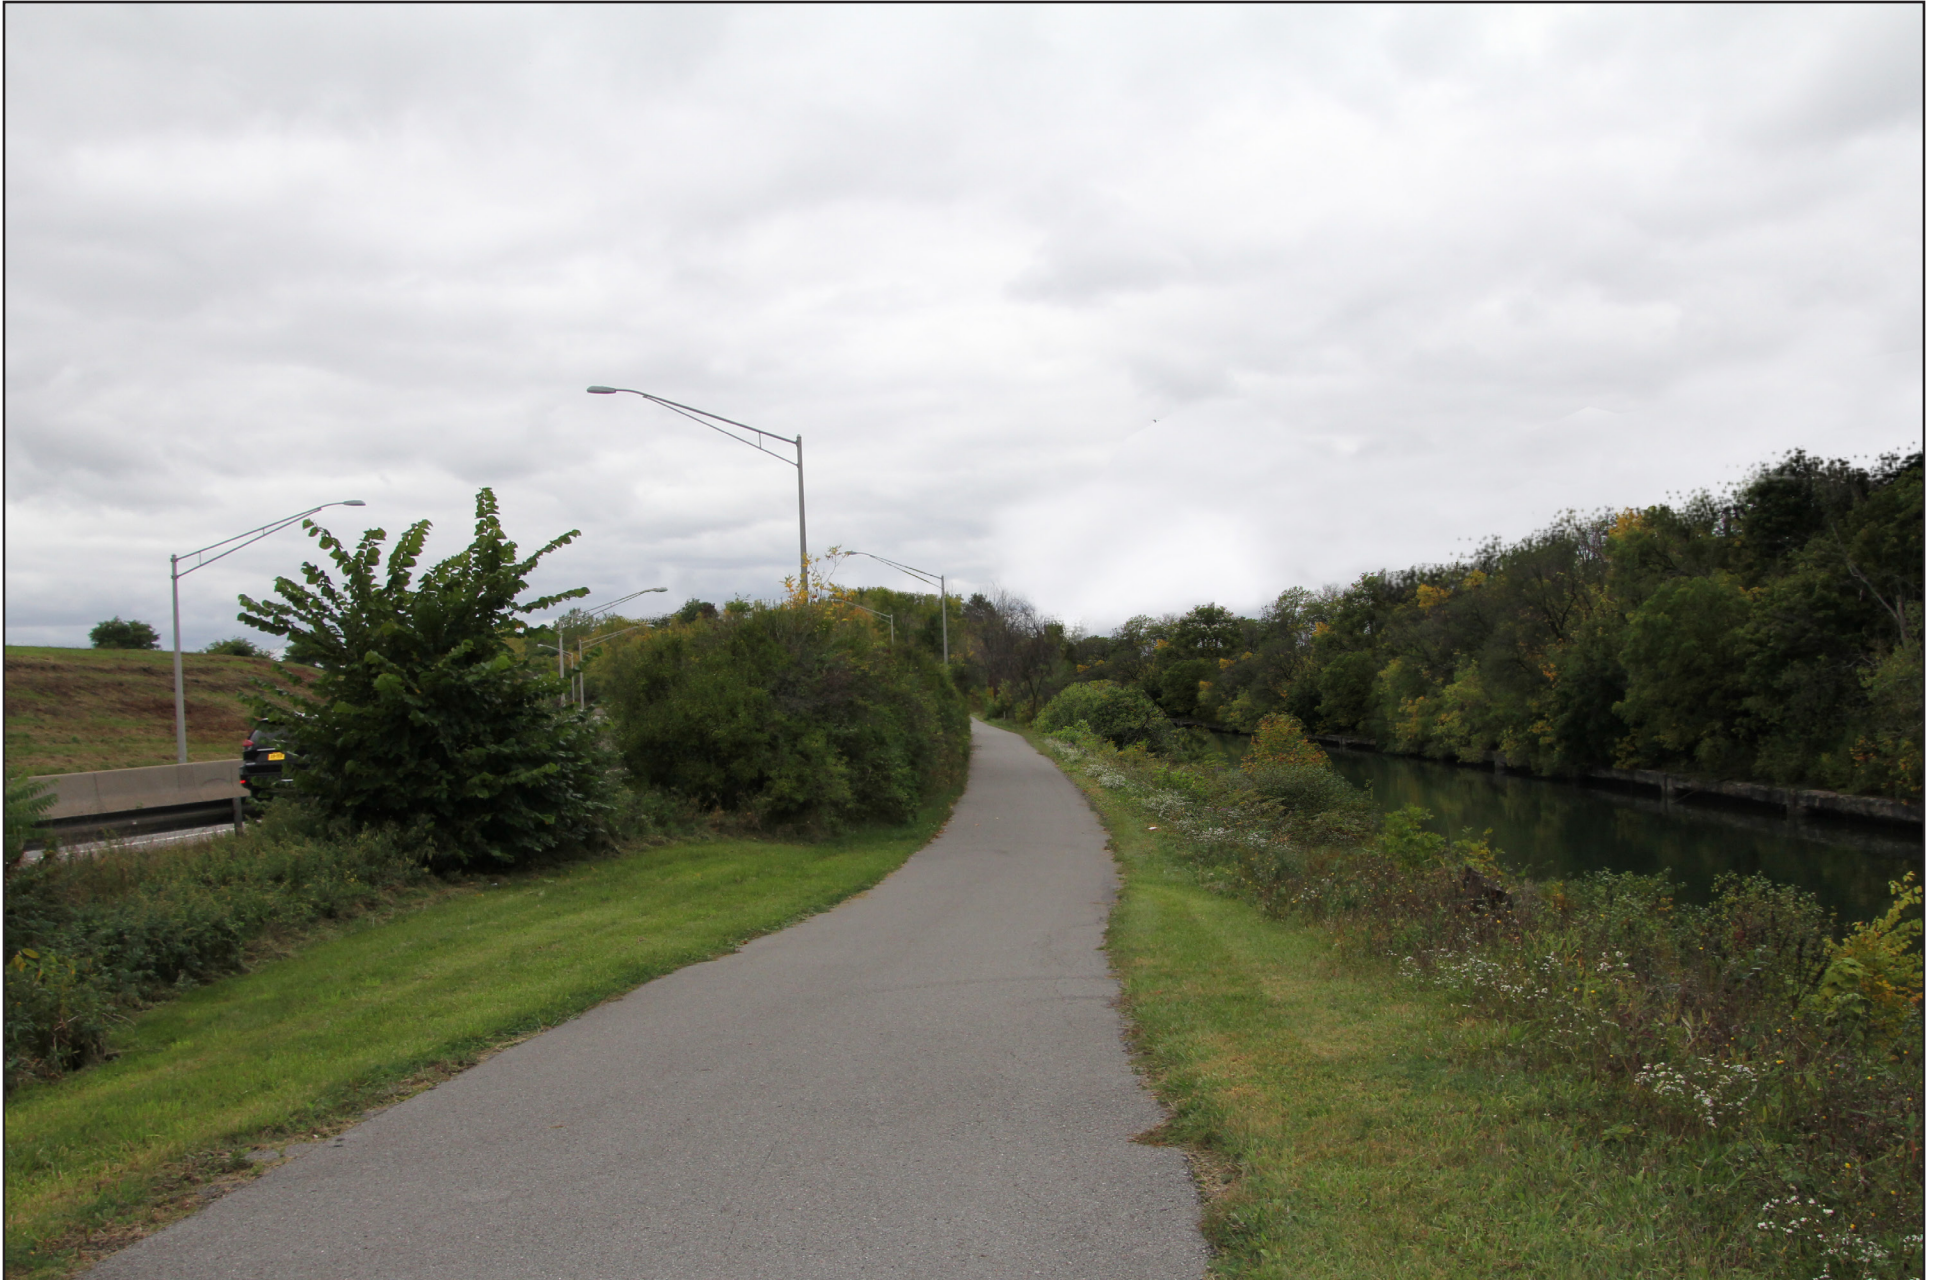
**Figure 3. Key View 1: Proposed Conditions**  
Greater Rochester International Airport  
Off Airport Tree Obstruction Removal  
Town of Chili & City of Rochester, Monroe County, NY
