ENVIRONMENTAL ASSESSMENT (EA)  
FOR RUNWAY 10-28 TREE OBSTRUCTION REMOVAL  
GREATER ROCHESTER INTERNATIONAL AIRPORT (ROC)

FAA AIP NO. 3-36-0102-103-2019  
CA NO. 1736

January 2020

Prepared By:  
CHA Consulting, Inc.

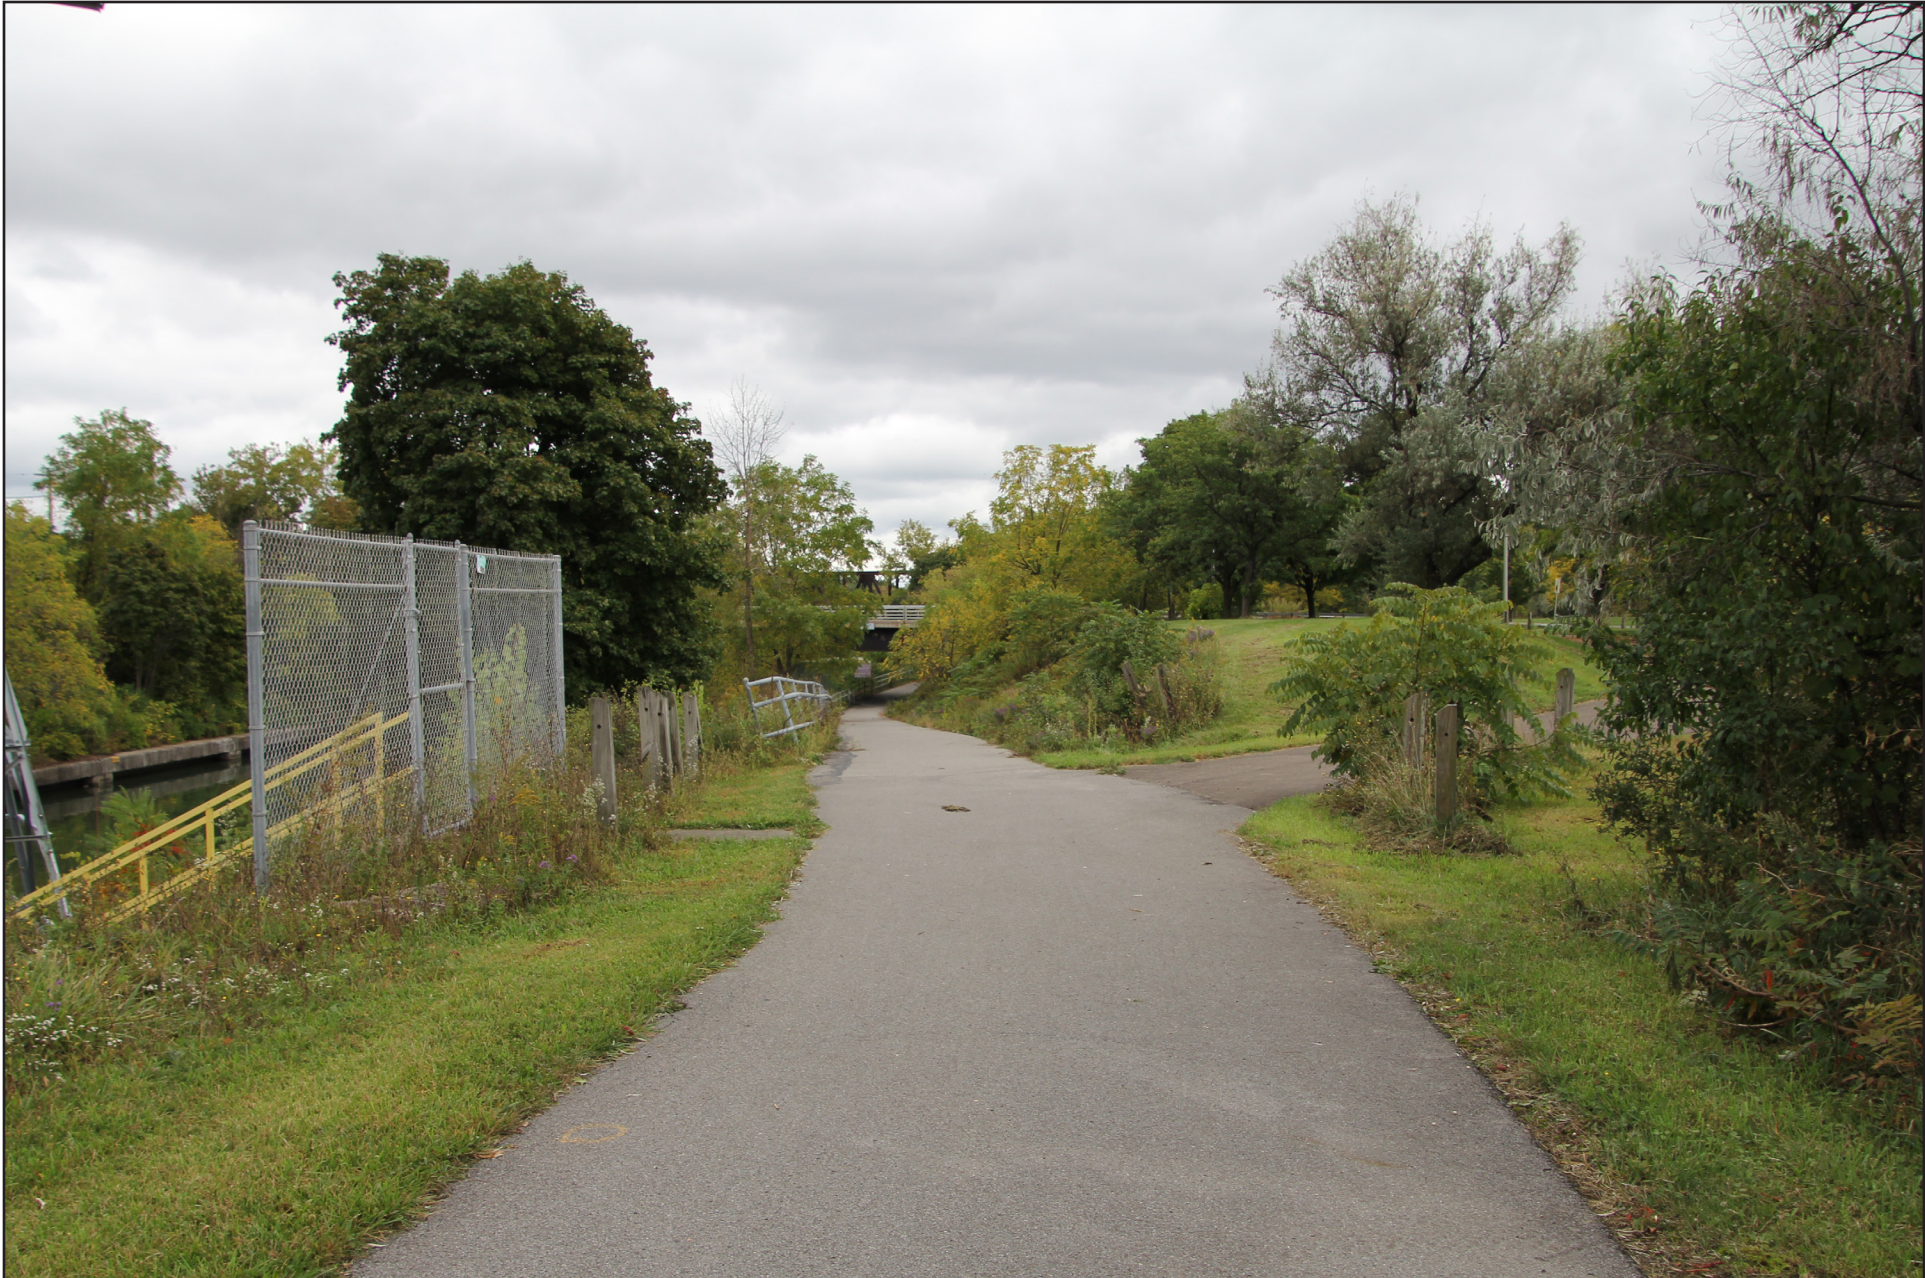
**Figure 4. Key View 2: Existing Conditions**  
Greater Rochester International Airport  
Off Airport Tree Obstruction Removal  
Town of Chili & City of Rochester, Monroe County, NY

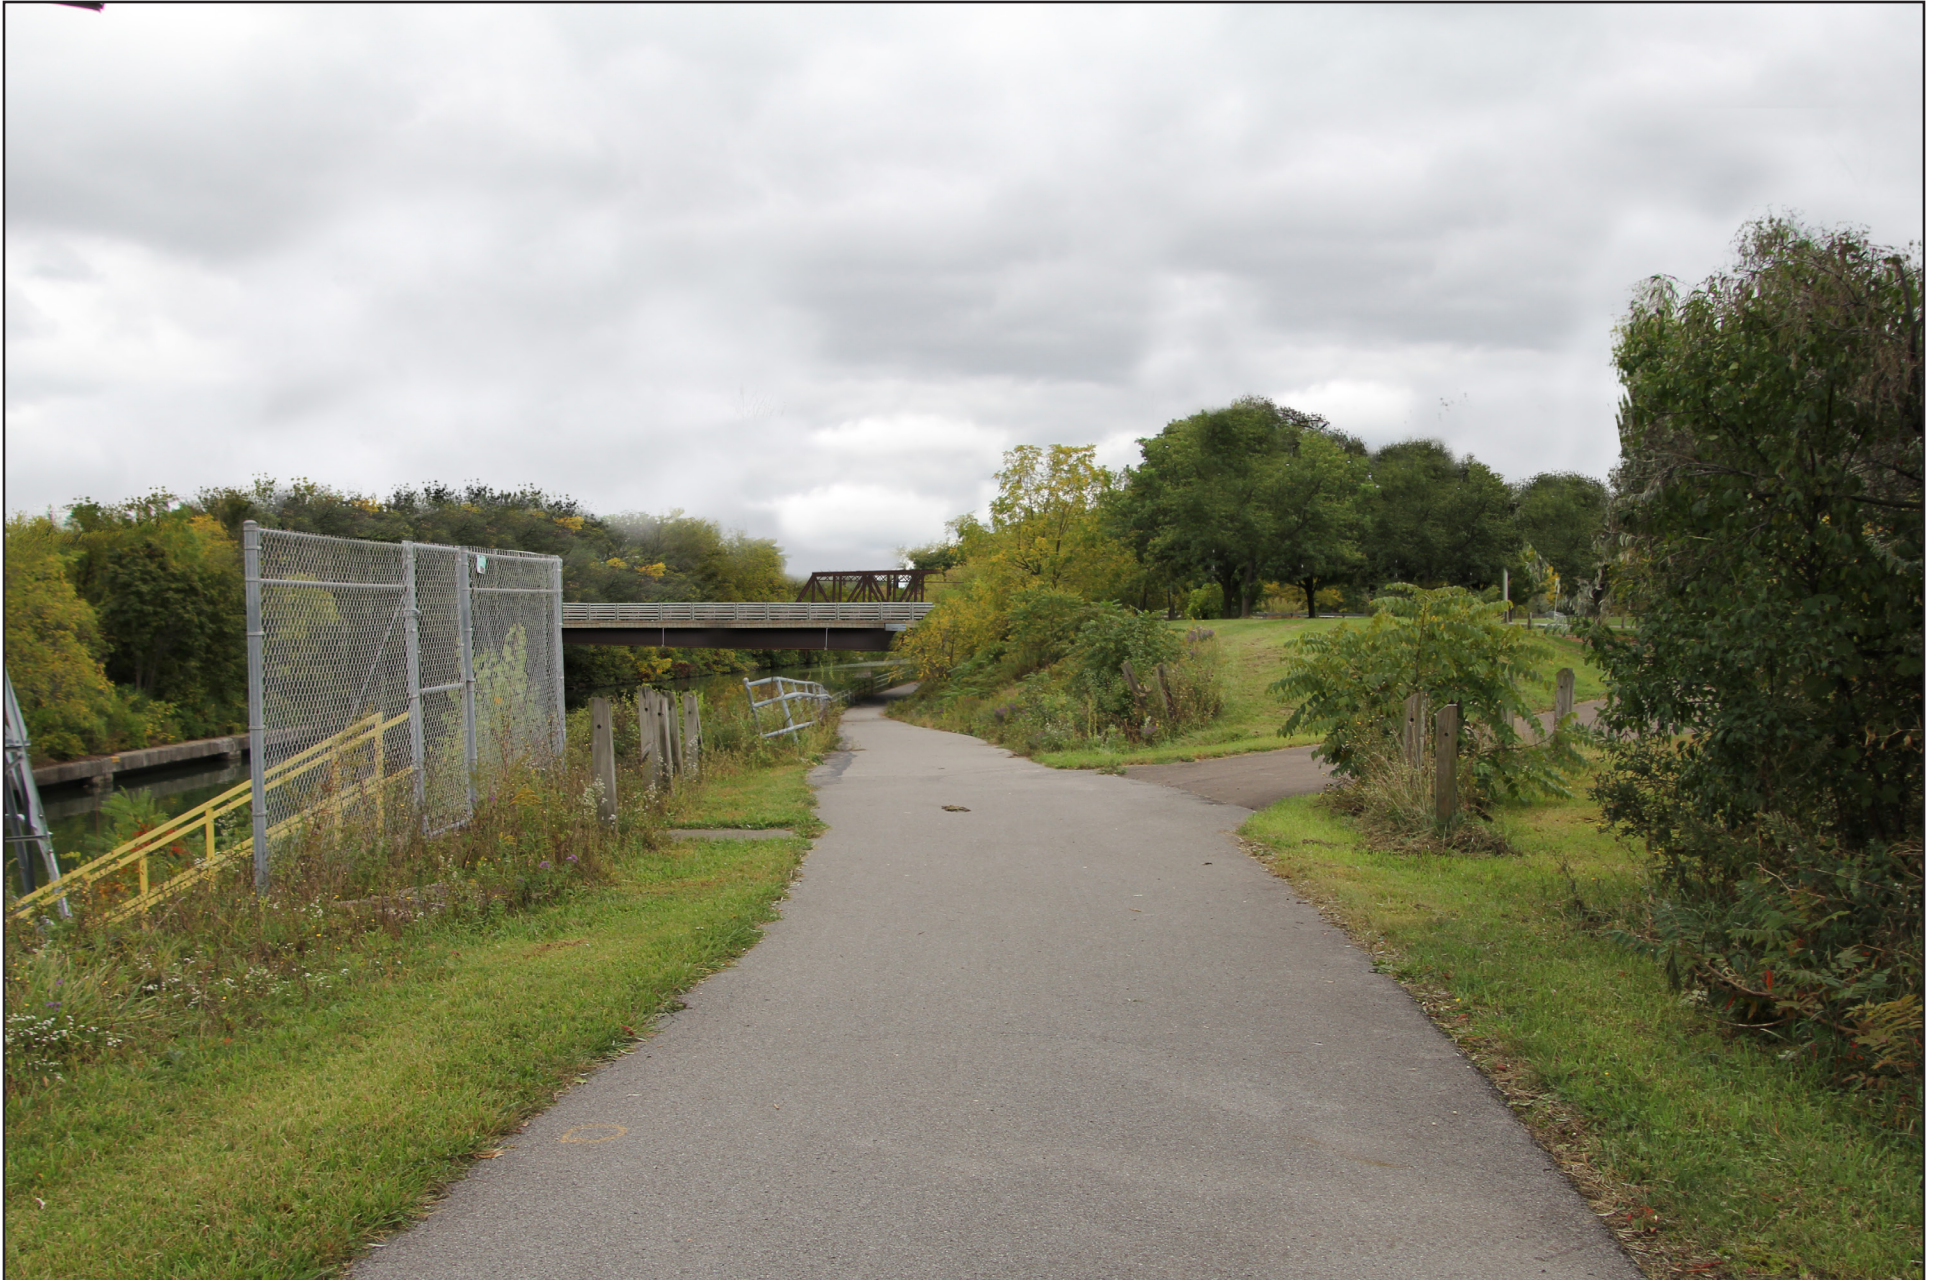
**Figure 5. Key View 2: Proposed Conditions**  
Greater Rochester International Airport  
Off Airport Tree Obstruction Removal  
Town of Chili & City of Rochester, Monroe County, NY

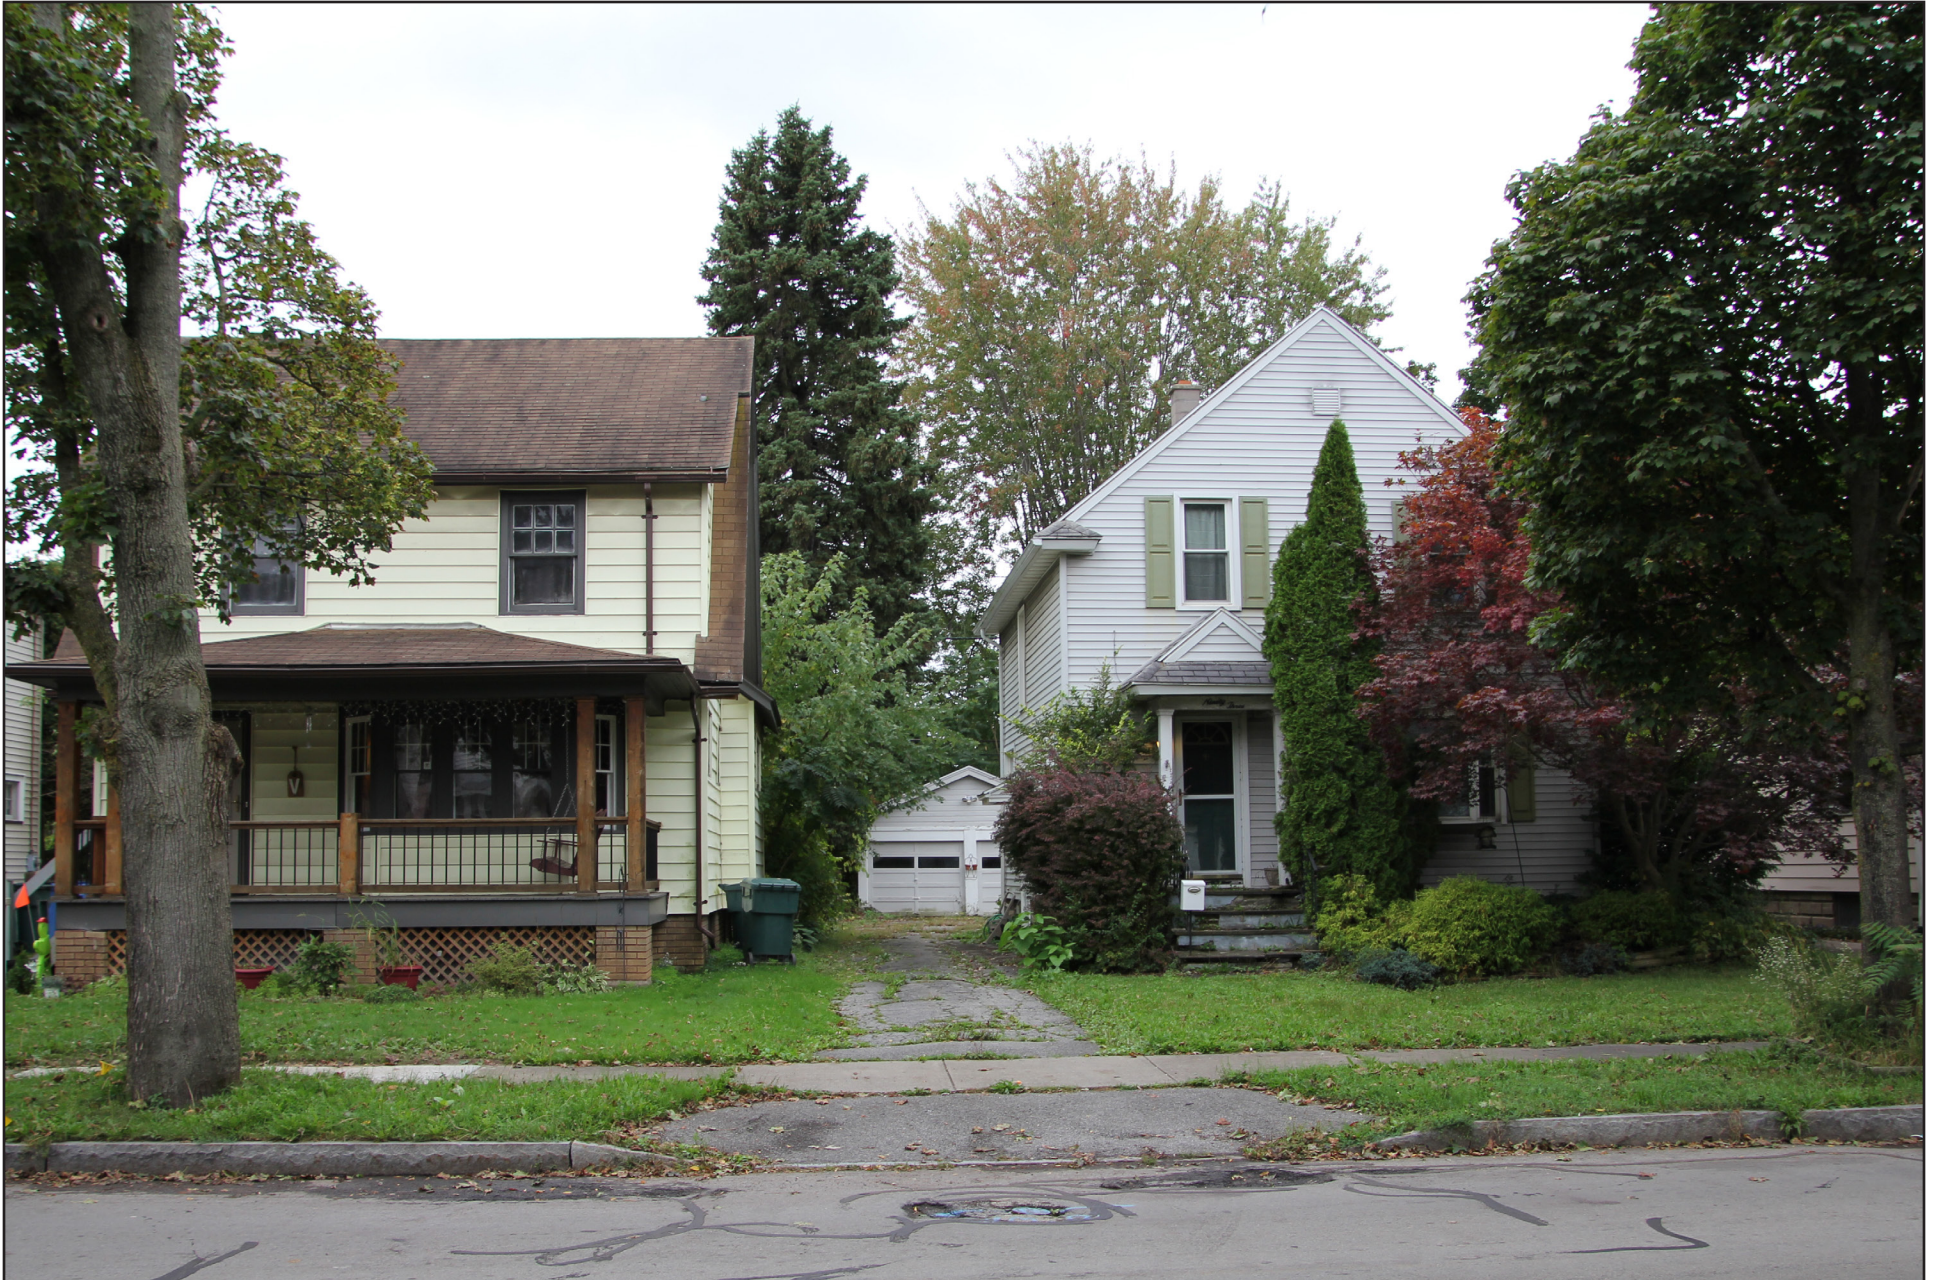
**Figure 6. Key View 3: Existing Conditions**  
Greater Rochester International Airport  
Off Airport Tree Obstruction Removal  
Town of Chili & City of Rochester, Monroe County, NY

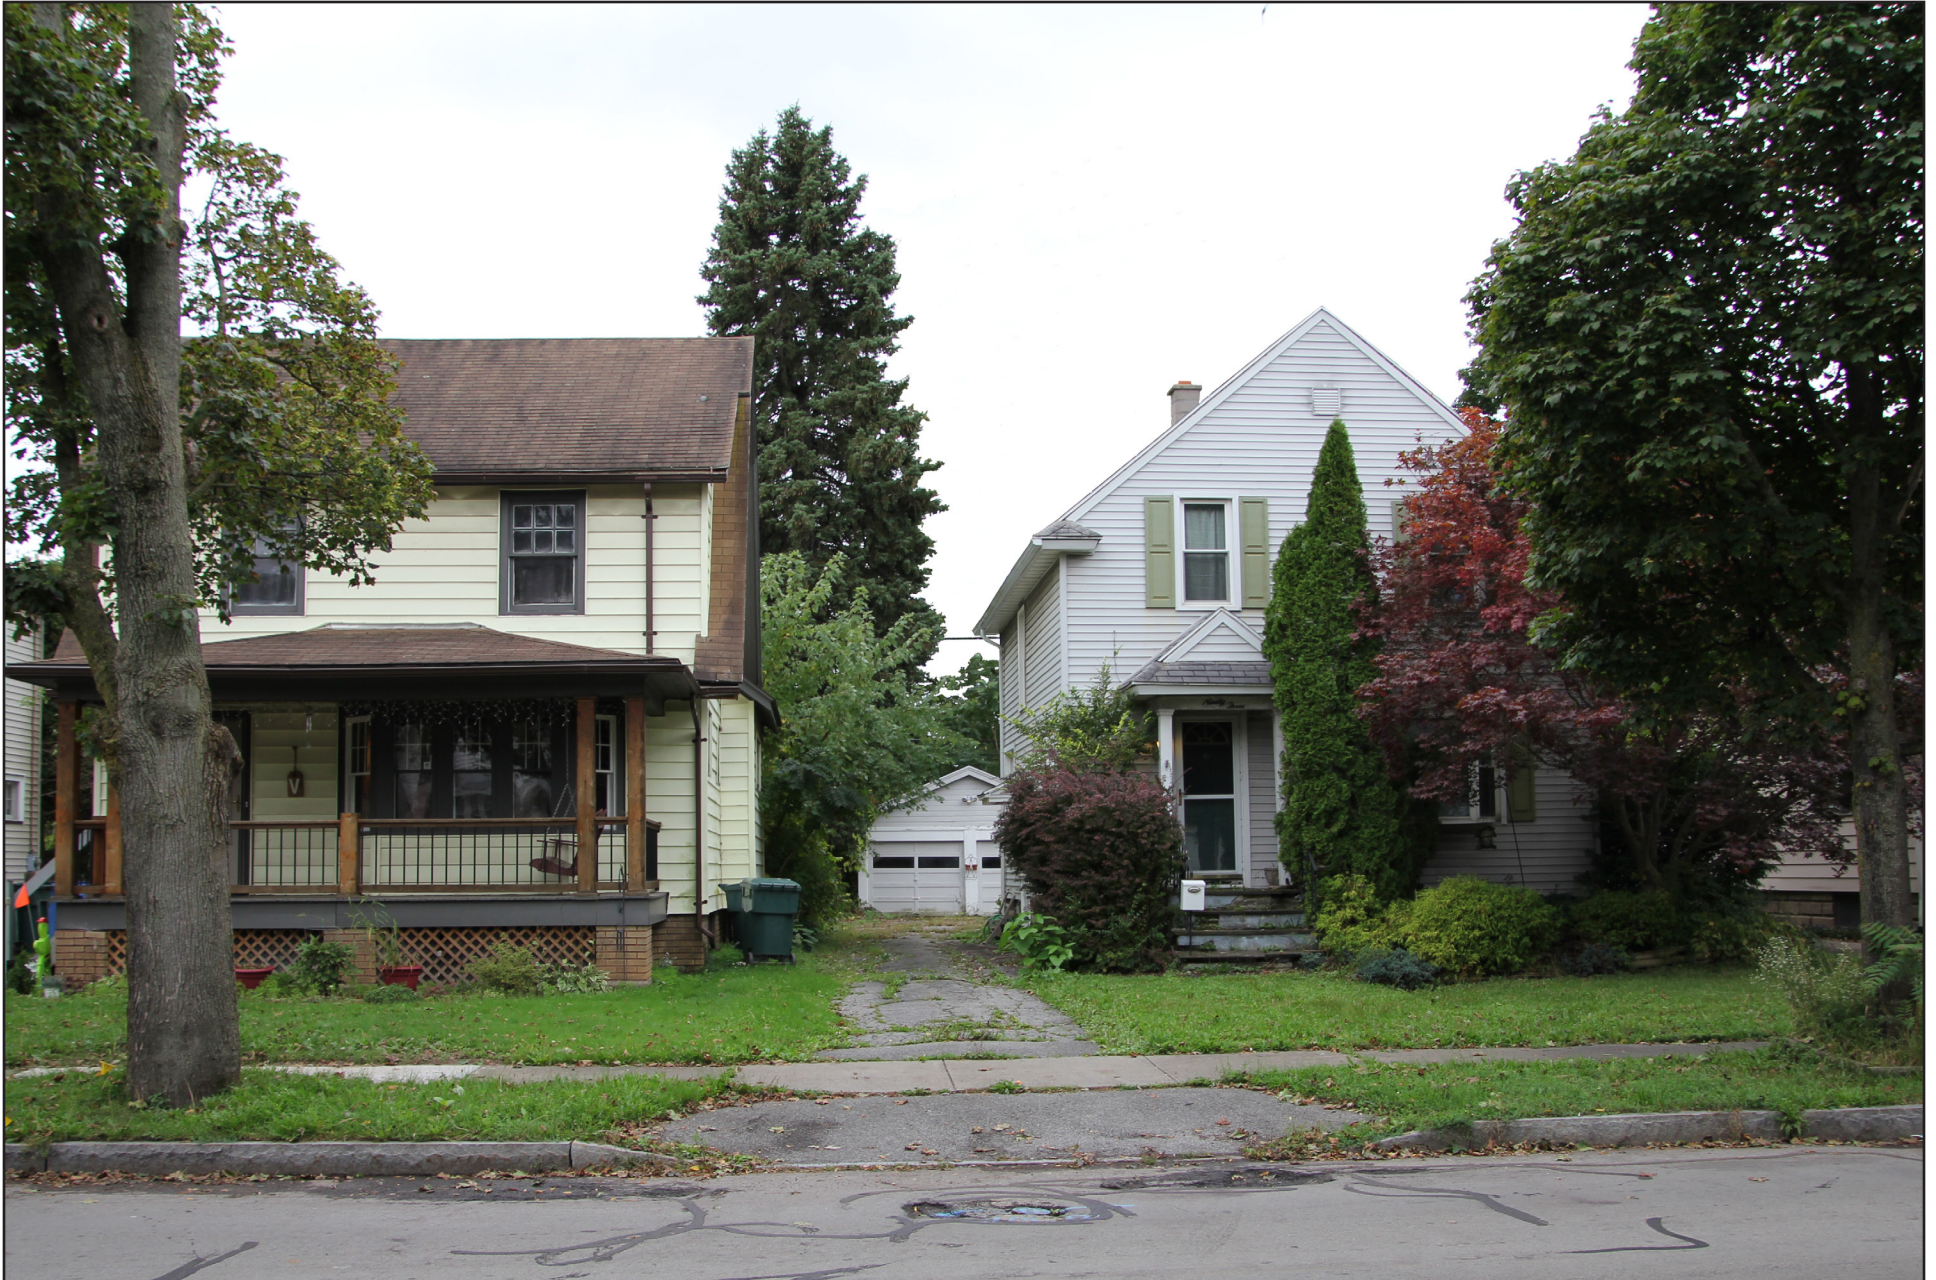
**Figure 7. Key View 3: Proposed Conditions**  
Greater Rochester International Airport  
Off Airport Tree Obstruction Removal  
Town of Chili & City of Rochester, Monroe County, NY
